PERMAFROST AND TERRAIN RESEARCH AND MONITORING: NORMAN

WELLS PIPELINE : Volume II - Research and Monitoring

Permafrost and Terrain Research and Monitoring: Norman Wells Pipeline

**Volume II
Research and Monitoring Results:
1983-1988**

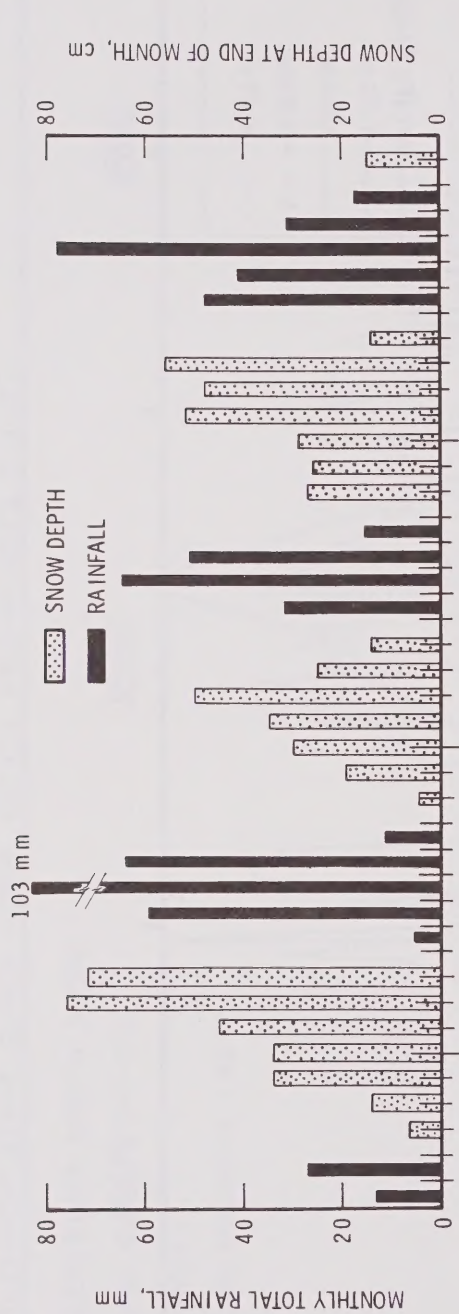
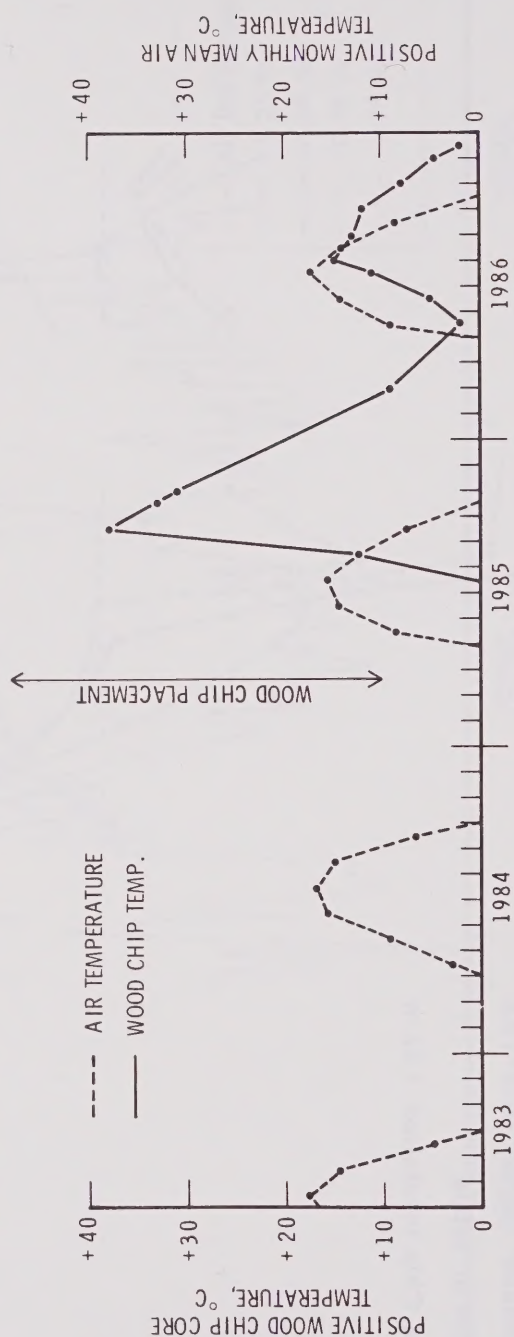
FORT SIMPSON (MACKENZIE RIVER SOUTH SLOPE)

Figure 6-10. Wood chip temperatures on Mackenzie River South slope compared with air temperature and precipitation data from Fort Simpson Airport.

As a consequence of the monitoring program, IPL personnel removed snow from the Mackenzie River south slope in March 1986 to try and dissipate the heat build-up. Snow removal appeared to be effective in lowering the temperatures in the wood chip layer at the top of the slope, but at the bottom of the slope the warm temperatures decreased until late May/early June of 1986 and then began to increase again. In February 1987, IPL removed all the wood chips from this slope. Part of the wood chips were placed back on the slope about one month later in a thinner layer.

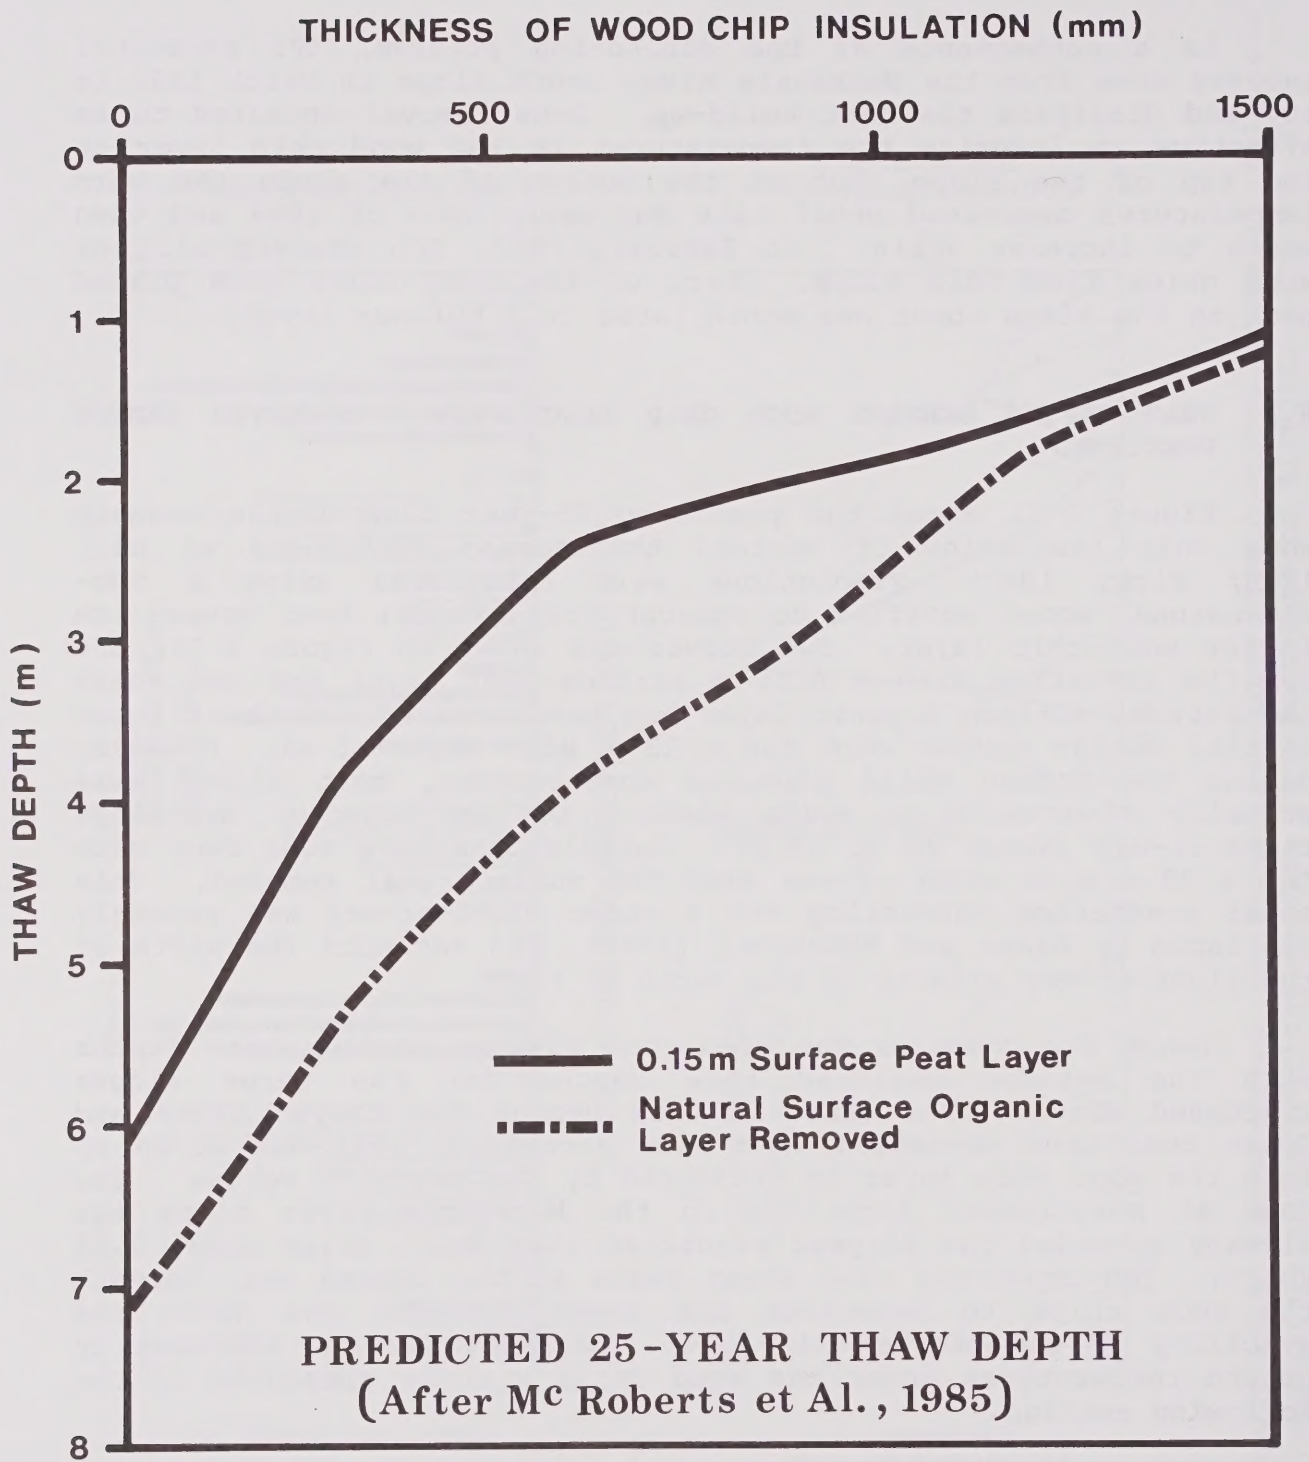
Figure 6-11 shows the predicted 25-year thaw depths beneath wood chip insulation of various thicknesses (McRoberts et al., 1985; Pick, 1987). Predictions were calculated using a one-dimensional model modified to account for internal heat generation in the wood chip layer. Two curves are shown in Figure 6-10; one for the situation with a 0.15 m surface peat layer and one where the natural surface organic layer has been removed. Both of these initial design curves were for a 13 m wide right-of-way. However, during the Norman Wells pipeline construction, most slopes were actually cleared to a width similar to the adjacent non-slope right-of-way (about 20 to 25 m). Calculations have also been made for a 20 m wide right-of-way with the surface peat removed. This other prediction accounting for a wider right-of-way was recently published by Hanna and McRoberts (1988), and reflects the width of the right-of-way effects on the depth of thaw.

Figure 6-11. Thaw depth predictions as a function of wood chip thickness (after McRoberts et al., 1985).
